**PEQUAWKET POWER
COMPANY DAM**

NH 00322

**PHASE I INSPECTION REPORT
NATIONAL DAM INSPECTION PROGRAM**

JUNE 1980

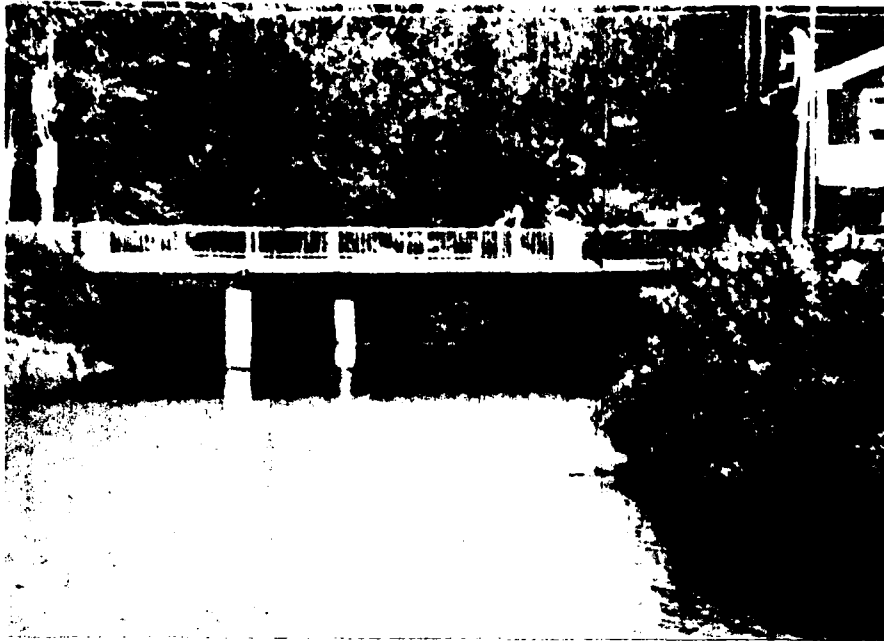
d. Reservoir Area. The slopes of the reservoir appear to be stable. No evidence of significant sedimentation was observed. The approach channel to the dam is slightly constricted by the opening under the highway bridge immediately upstream of the dam, but is wide and unobstructed upstream of the bridge. There are no trees overhanging the approach channel for a distance of a few hundred feet upstream from the dam.

Photo No. 1 - Main Street Bridge and approach channel
to dam

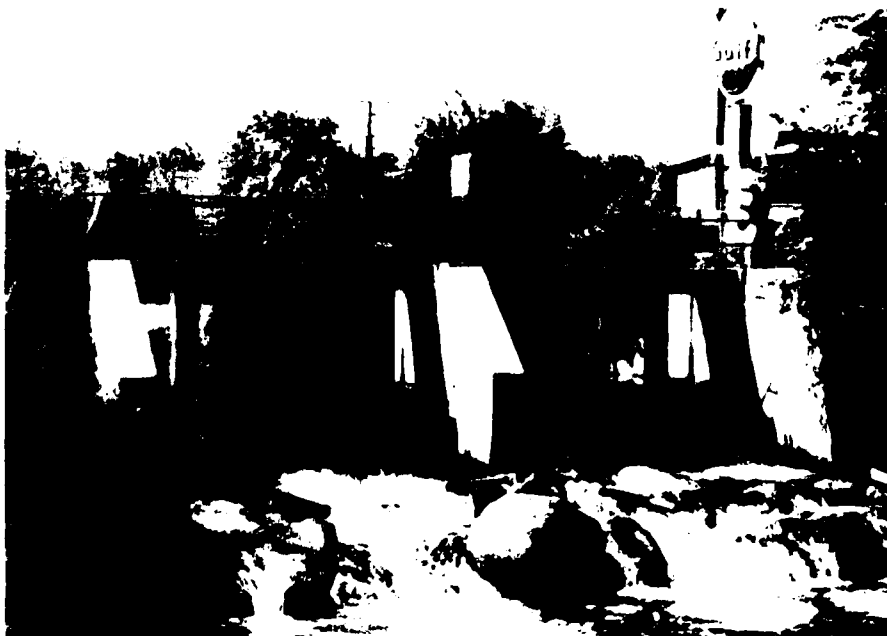
Photo No. 2 - General view of downstream face of dam
